Engineering Geomorphological Assessment and Slope Hazard Identification of the Haast Pass Highway Corridor

State Highway Six, Haast Pass, New Zealand

Master of Science in Engineering Geology

by
Andrew Timothy Walsh
2015

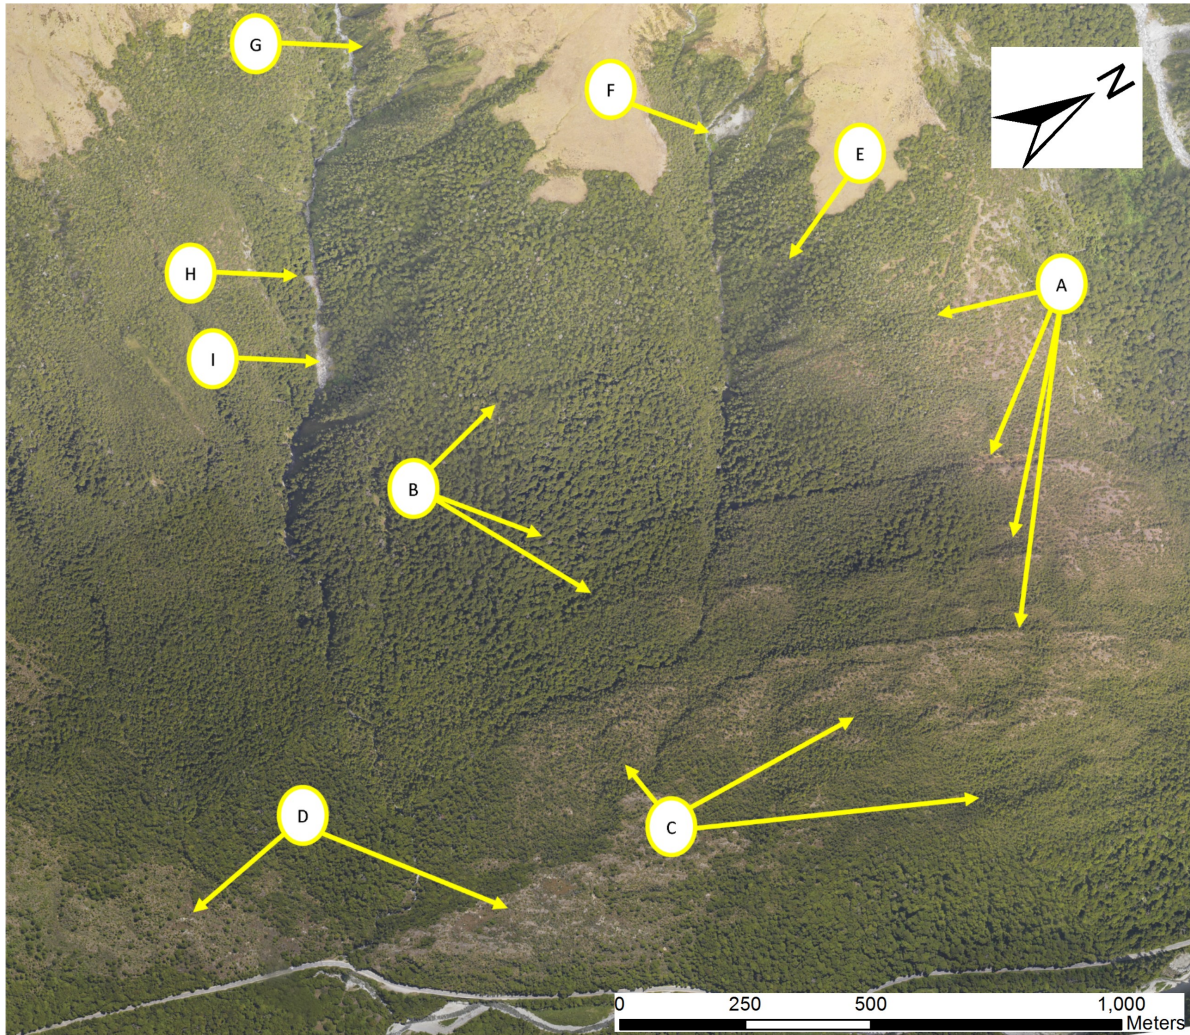
Identification of surface units and slope processes is possible with aerial photography, but as most of the zone is covered by dense vegetation the extent that can be identified is limited. The most obvious features are four parallel lineations running approximately north to south (Figure 3.2 A). Three of the lineations can be observed in the more densely vegetated areas where variations in the tree canopy are representative of the sharp changes in the topographic surface below (Figure

3.2 B). Immediately below the four parallel lineations is an area of hummocky topography with the top of the hummocks lacking vegetation (Figure 3.2 C). The hummocky area can be seen extending down slope from the lineations to the dense vegetation directly above the road (Figure 3.2 C lower arrow). To the south of the hummocky area sections of the slopes above the highway completely lack vegetation and the surface visible is coloured light brown to grey (Figure 3.2 D). In all other sections of the zone, including all slopes next to the highway, dense vegetation obscures the ground surface, preventing identification from aerial photography.

Evidence of active slope processes are visible on some parts of upper slopes above Grangers Creek. The slopes above the creek are covered by dense vegetation with the exception of one area where density varies (Figure 3.2 E) and another where vegetation is completely absent (Figure 3.2 F). In the area of variable vegetation density it is possible that mass movement processes have resulted in a loss of vegetation and a reduction in density compared with surrounding areas. An example of what this may look like is visible on the same side of the creek just upstream (Figure 3.2 F). This area lacks any vegetation and does not appear to be an exposure of bedrock. The light coloured material is almost certainly a veneer of regolith over bedrock that has been exposed by a debris slide involving movement of the top cover of regolith and the vegetation.

Slope processes are visible in parts of Cross Creek and have resulted in the removal of vegetation exposing bedrock and regolith. Bedrock exposures can be seen in the creek bed and streams running into the creek in the upper reaches (Figure 3.2 G). Small exposures of regolith are visible on slopes on the true right side of the creek in the upper section of the creek (Figure 3.2 H) as well as larger exposures (Figure 3.2 I) just before the creek enters a narrow dark steep sided channel. Regolith is only exposed at the toe of slopes where river incision has resulted in destabilisation of the slope that has then resulted in mass movement of the surface materials. It is not possible to

Figure 3.2: A)Foliation aligned lineations (B) Offset tree heights in line with lineations on slopes to the north (C) Area of hummocky topography (D) Area with sparse vegetation that appears to consist of rock (E) Variable density of vegetation (F) Exposed regolith where a debris slide has occurred (G) Bedrock slope with foliation aligned lineations (H) Small exposure of regolith next to stream (I) Exposure of regolith alongside stream.

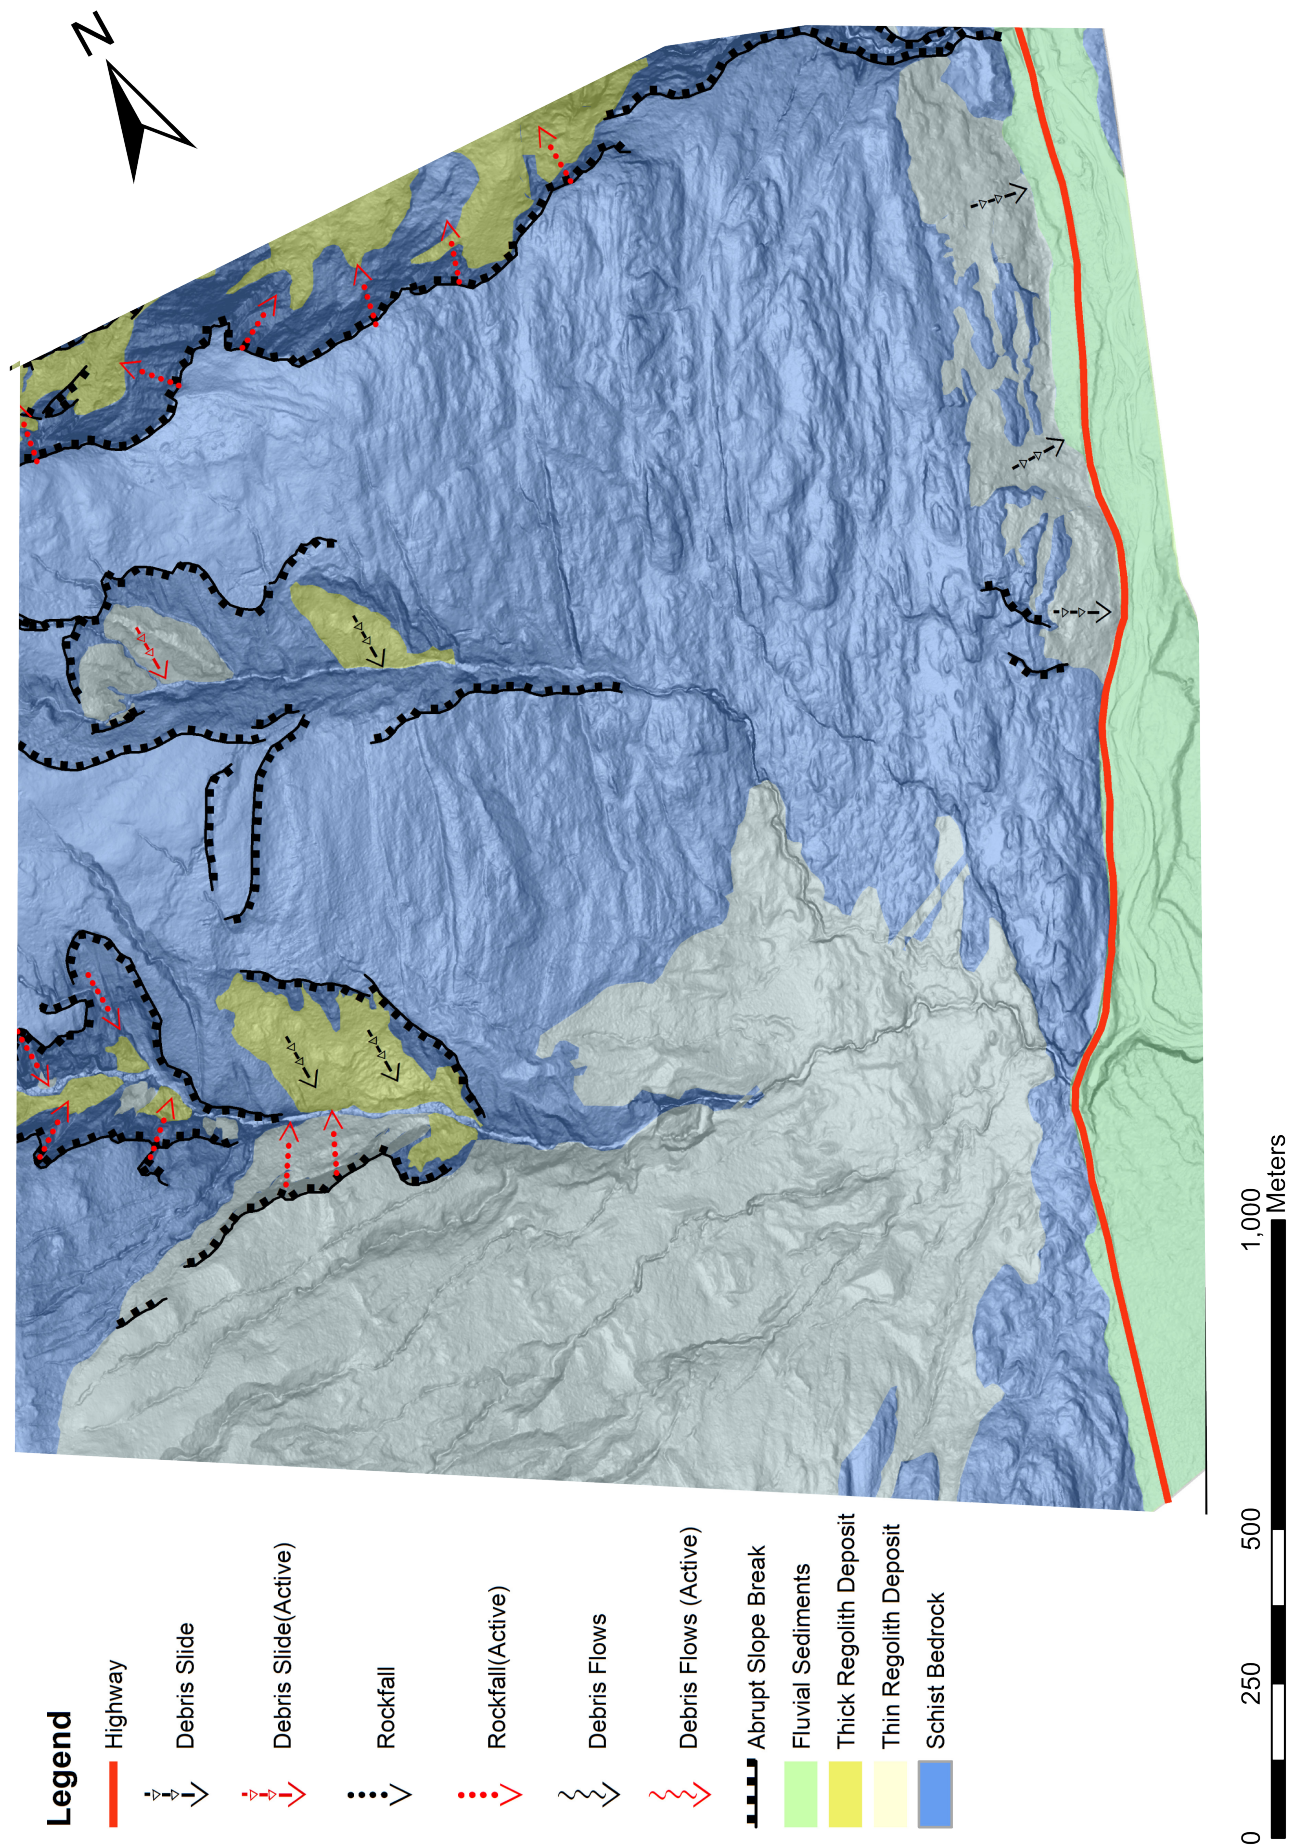
4. **Deep Seated Gravitational Failures:** A large area of the bedrock slope between Cross and Grangers Creeks appears to show signs of rockmass lineation deformation in the LiDAR surface and there also appears to be a headscarp feature at the top of the slope. It was not possible to reach the area during ground investigations to evaluate the area more closely but given the small amount of deformation that has taken place since the slope was de-buttressed after the last glaciation the slope is probably not an immediate threat to the highway. It should, however, be considered to be in an unknown state of activity until confirmed otherwise.

Figure 3.8: Geomorphology of the western hillslope above the highway between the Haast Pass Summit and Wilson Creek. The background image is a hillshade of the LiDAR model with an illumination direction of 300 and an azimuth of 35 degrees.

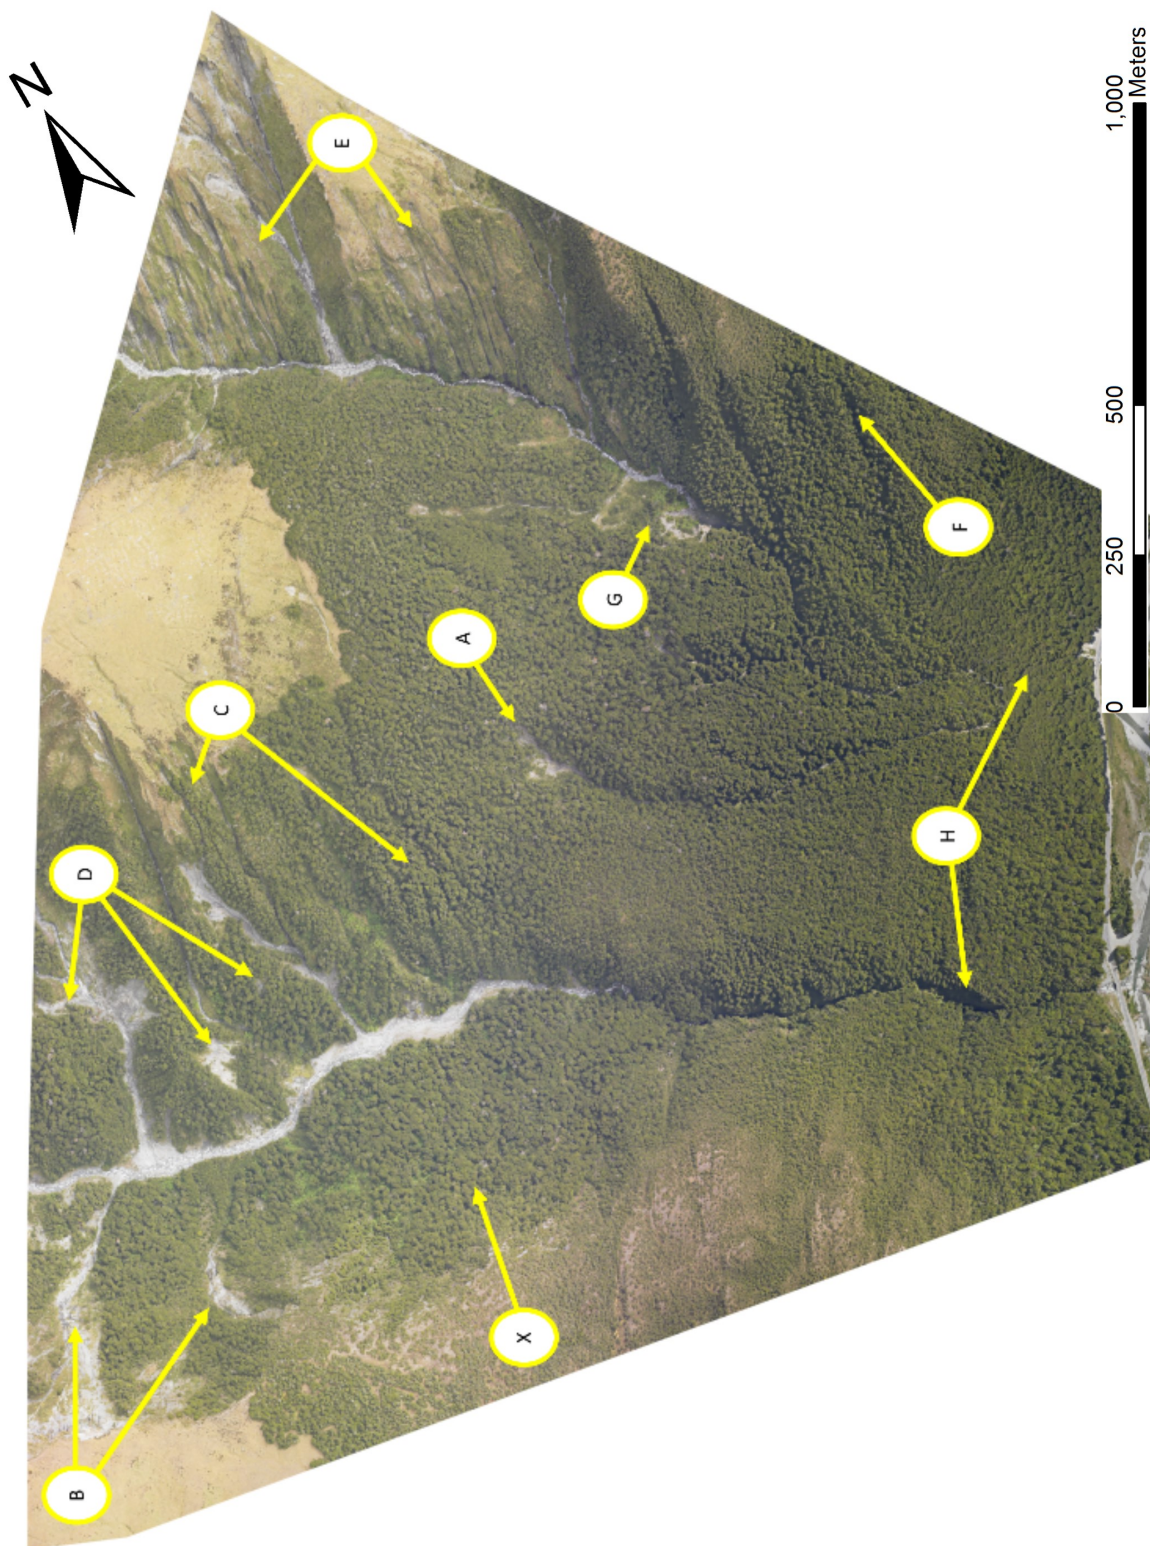
The northern side of Robinson Creek is dominated by bedrock slopes while the southern side is largely obscured by vegetation. Persistent parallel lineations on the slope to the north of the creek extend from creek level to the top of the slope (Figure 3.9E). These lineations extend from the western extent of the zone down to near highway level, however, it appears that near highway level the lineations are only visible near the tops of slope (Figure 3.9F). The lineations also align with regional bedrock foliation indicating that the slope is likely composed of bare bedrock. The lineations visible on the northern side of the creek are not present on the southern side; Instead a dense cover of vegetation completely obscures the ground surface. Only small areas of the slopes surface are visible where landsliding has exposed the underlying materials revealing light grey coloured unconsolidated material. The material is likely a cover of regolith and may cover the majority of the slope, but this cannot be confirmed with aerial photography.

The ability to identify the geomorphic units on slopes facing the highway is extremely limited due to the very dense vegetation cover over most of the slope. The presence of two large gullies can be observed as changes in the height of the tree canopy as a result of the changes in the underlying topography (Figure 3.9A). The material that is visible where vegetation has been removed by landsliding processes is grey in colour and appears to be composed of unconsolidated material. Based on the visible material it is likely that regolith is covering bedrock as it is not visible anywhere in this exposure. The presence of bedrock on the lower slopes can be inferred from the highly channelised nature of the creeks that flow in gorges before entering the Haast River. Direct observations of bedrock exposures are not visible in the aerial photo due to the dense vegetation cover.

Figure 3.9: (A) Regolith material exposed in gully due to mass movement (B) Areas where bare rock is exposed and likely where rockfall has taken place recently (C) Foliation aligned lineations exposed on upper slopes north of Wilson Creek (D) Exposure of regolith due to mass movement processes (E) Foliation aligned lineations exposed on upper slopes north of Robinson Creek (F) Subtle lineations visible in vegetation on upper slopes (G) Exposures of regolith cover caused by mass movements south of Robinson Creek (H) Creeks flowing in steep gorges before entering the Haast River.

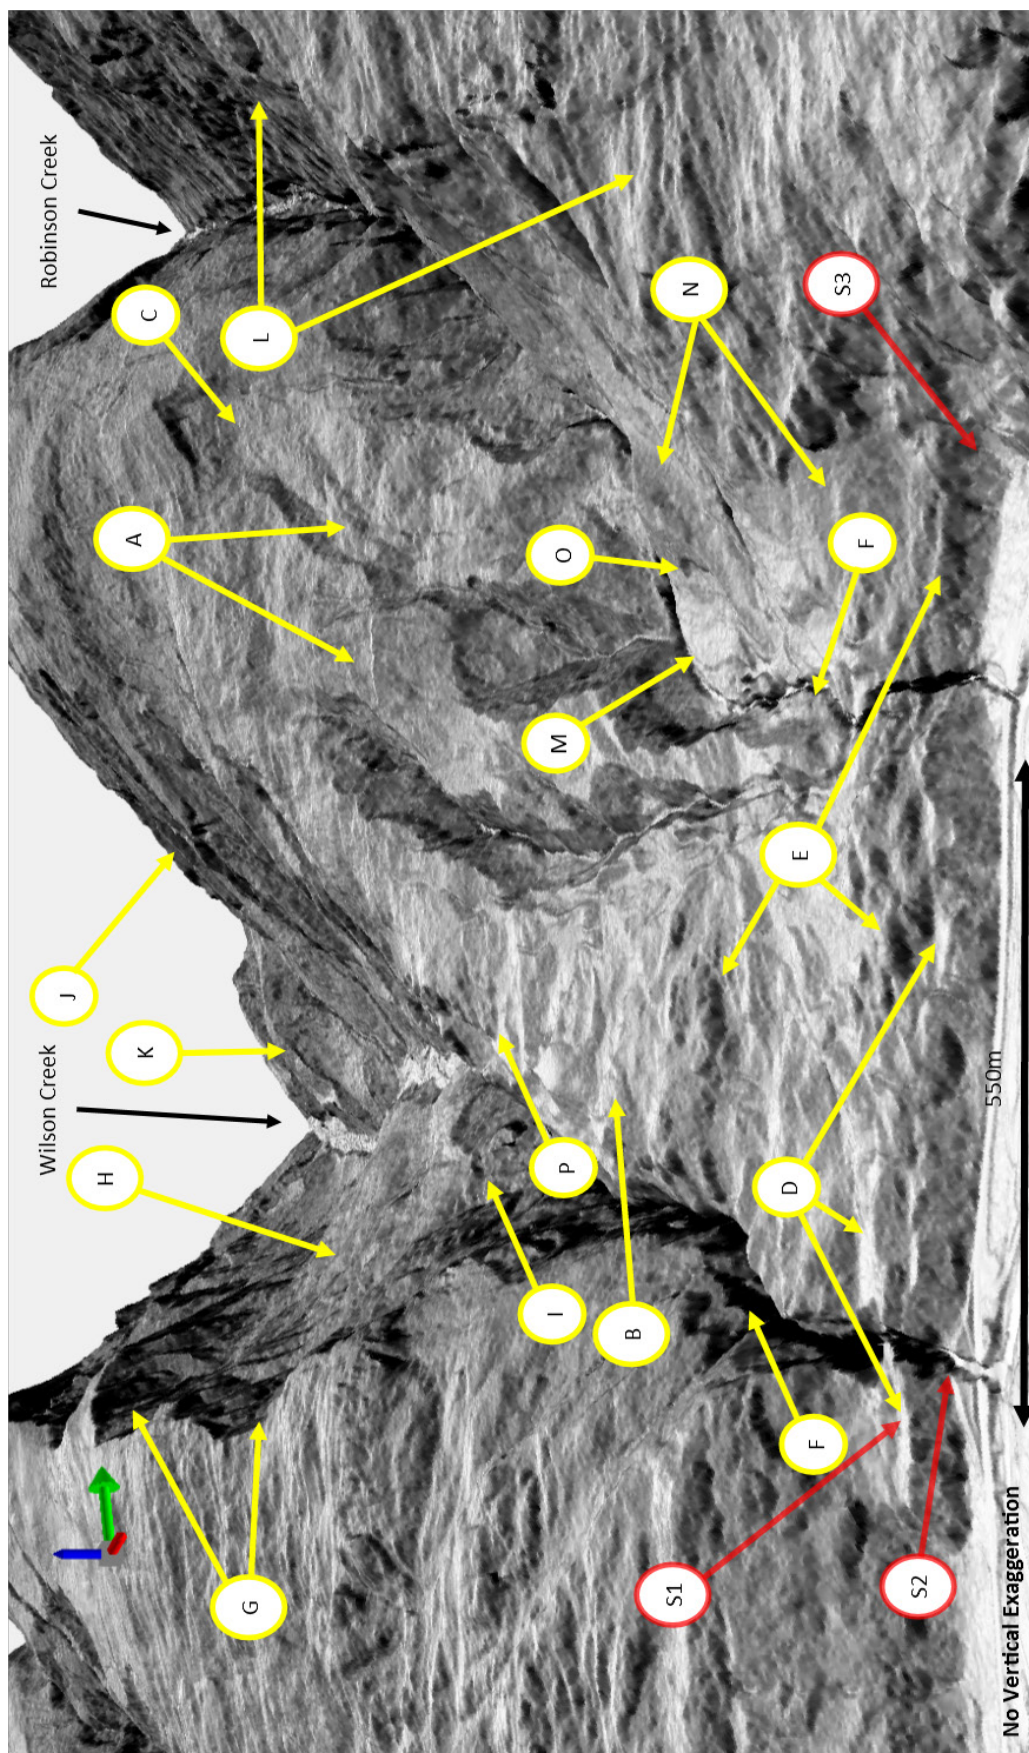
The slope facing the highway north of Wilson Creek and south of Robinson Creek is composed of a thin regolith veneer over bedrock. Bedrock textures visible in other parts of the zone are absent from this slope and instead two differing surface textures are visible (Figure 3.10 A and B). The textures on the upper slope appear more hummocky and irregular suggesting the material is likely to be regolith scoured from the failure of schist bedrock further up slope. An example of the processes of bedrock failure and deposition of regolith material on the slope is visible where a landslide has deposited regolith over the slope (Figure 3.10 C). The lower slope is also covered by regolith, however, the appearance differs from the irregular textures of the upper slopes. The surface is smooth and planar with many flat lying surfaces across the slope that aligning to form a planar but discontinuous surface (Figure 3.10 D). The presence of the steep sided gorges formed in bedrock to the north and south of the slope combined with the presence of isolated areas of bedrock on the lower slopes (Figure 3.10 E) indicates that the cover of regolith is relatively thin.

Large Regolith deposits below steep bedrock slopes in the upper reaches of Wilson Creek are clearly visible in the LiDAR model. On the south side of the creek large bedrock cliffs are visible at the top of the slope with planar surface textures on the cliff face formed by rockmass defects (Figure 3.10 G). Below the cliffs a very extensive and thick regolith deposit covers approximately half the slope from above the gorge to the western extent of the zone (Figure 3.10 H). Within the regolith deposit a number of internal scarps suggest that mass movements of the material, likely debris sliding, has or is taken place (Figure 3.10 I). The slope on the northern side of the creek is composed of bedrock with amounts of regolith covering eastern portion of the creek near the gorge entrance (Figure 3.10 J). At the western extent of the zone thicker deposit of regolith covers the lower part of the bedrock slope. Within the regolith material a number of landslide features are visible with headscarps and lateral scarps as well as main landslide bodies visible. The headscarp area of the landslide feature visible in the LiDAR model (Figure 3.10 K) also corresponds to an area of disturbed vegetation in the aerial photo, suggesting recent mass movements of the regolith deposit 3.9 D middle arrow).

The slopes above Robinson Creek consist of bare bedrock on the northern side and bedrock covered by variable thicknesses of regolith on the southern side. In the upper half of the creek the slopes on the northern side are entirely composed of bare bedrock with lineations parallel to bedrock foliation visible cutting across the slope (Figure 3.10 J upper arrow). On the southern side the upper half of the slopes above the creek consist of a thin cover of regolith over most of the slope with small areas of bedrock exposed in cliffs near the base of the slope. In the lower half of the creek the slopes become covered in thicker deposits of regolith with two distinctive regolith textures visible. The textures visible next to the channelised creek appear planar, smooth and flat lying and look similar in appearance to the lower slopes between Robinson and Wilson creeks (Figure 3.10 M). Above the planar smooth textured regolith a more irregular hummocky regolith texture is visible extending up slope (Figure 3.10 N). Parts of the irregular textured regolith appear to have been eroded and replaced by the planar, smooth flat lying regolith (Figure 3.10 O). Above the irregular textured regolith the slope displays structures consistent with bare bedrock and is inferred that this area is composed of bedrock (Figure 3.10 L).

Figure 3.10: The background image is a slope-shaded image with Light colours indicate shallowly sloping areas with steep areas appearing as dark colours. (A)Irregular and rough regolith textures on upper slopes (B)Planar smooth regolith textures over lower slopes (C)Deep regolith cover below landslide scarp (D)Flat planar surfaces at similar elevations (E)Small exposure of bedrock (F)Creeks flowing in steep gorges (G)Large cliffs on the southern side of Wilson Creek (H)Regolith deposit at the base steep cliffs (I)Scarp within regolith material indicating landslide activity (J)Bedrock slope with foliation aligned lineations visible (K)Regolith material at base of bedrock slope (L)Bedrock exposed on upper slopes with foliation lineations visible (M)Smooth planar regolith textures (N)Irregular rough regolith textures (O)Area where irregular rough textures appear to have been eroded. S1 and S2 refer to ground truthing sites one and two.

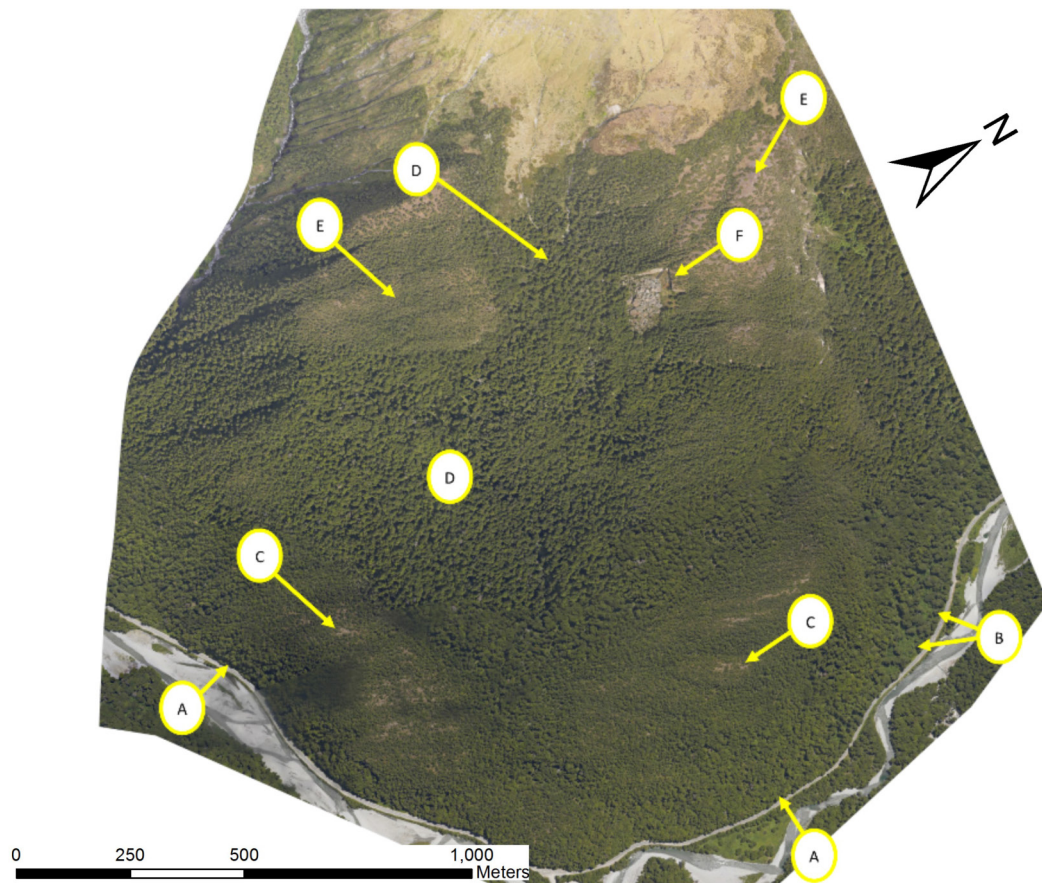
Figure 3.14: (A) Areas of dense vegetation next to the highway (B) Areas where younger vegetation is present and appears lighter in colour than surrounding vegetation. (C) Sparsely vegetated areas appearing light brown in colour surrounded by denser vegetation. (D) Very dense vegetation extending across the mid slope and in a narrow area to the top of the slope. (E) Areas of Sparse vegetation with subtle foliation aligned lineations visible on the southern side of the slope.(F) A landslide originating in the sparsely vegetated area on the northern side of the slope. The scarp and the landslide deposit are visible and appear to be associated with a rock/debris slide.

Vegetation cover in this part of the Haast Pass is highly variable with some are covered by dense vegetation and others with sparse or no vegetation at all. The areas adjacent to the highway are covered by very dense vegetation that completely obscures the ground surface (Figure 3.14 A); there does not appear to be any recent slope failures in this area and only two areas of slightly younger vegetation suggests past slope failures have occurred in the past(Figure 3.14B). Above the slopes next to the highway the vegetation variability becomes more pronounced. Areas of sparse to no vegetation appear light brown in colour and are surrounded by vegetation less dense than areas next to the highway (Figure 3.14 C). An area of particularity dense vegetation extends across the the middle of the slope and extends up to the top of the slope confined to a narrow area (Figure 3.14 D). Either side of the narrow area of dense vegetation the slope is sparsely vegetated with the southern side appearing to also show sighs of foliation aligned lineations (Figure 3.9 E). The only clear evidence of a mass movement visible in aerial photography is a small landslide with a well defined headscarp on the northern side of the upper slope where a rockslide has originated from an area of sparse vegetation (Figure 3.14 F).

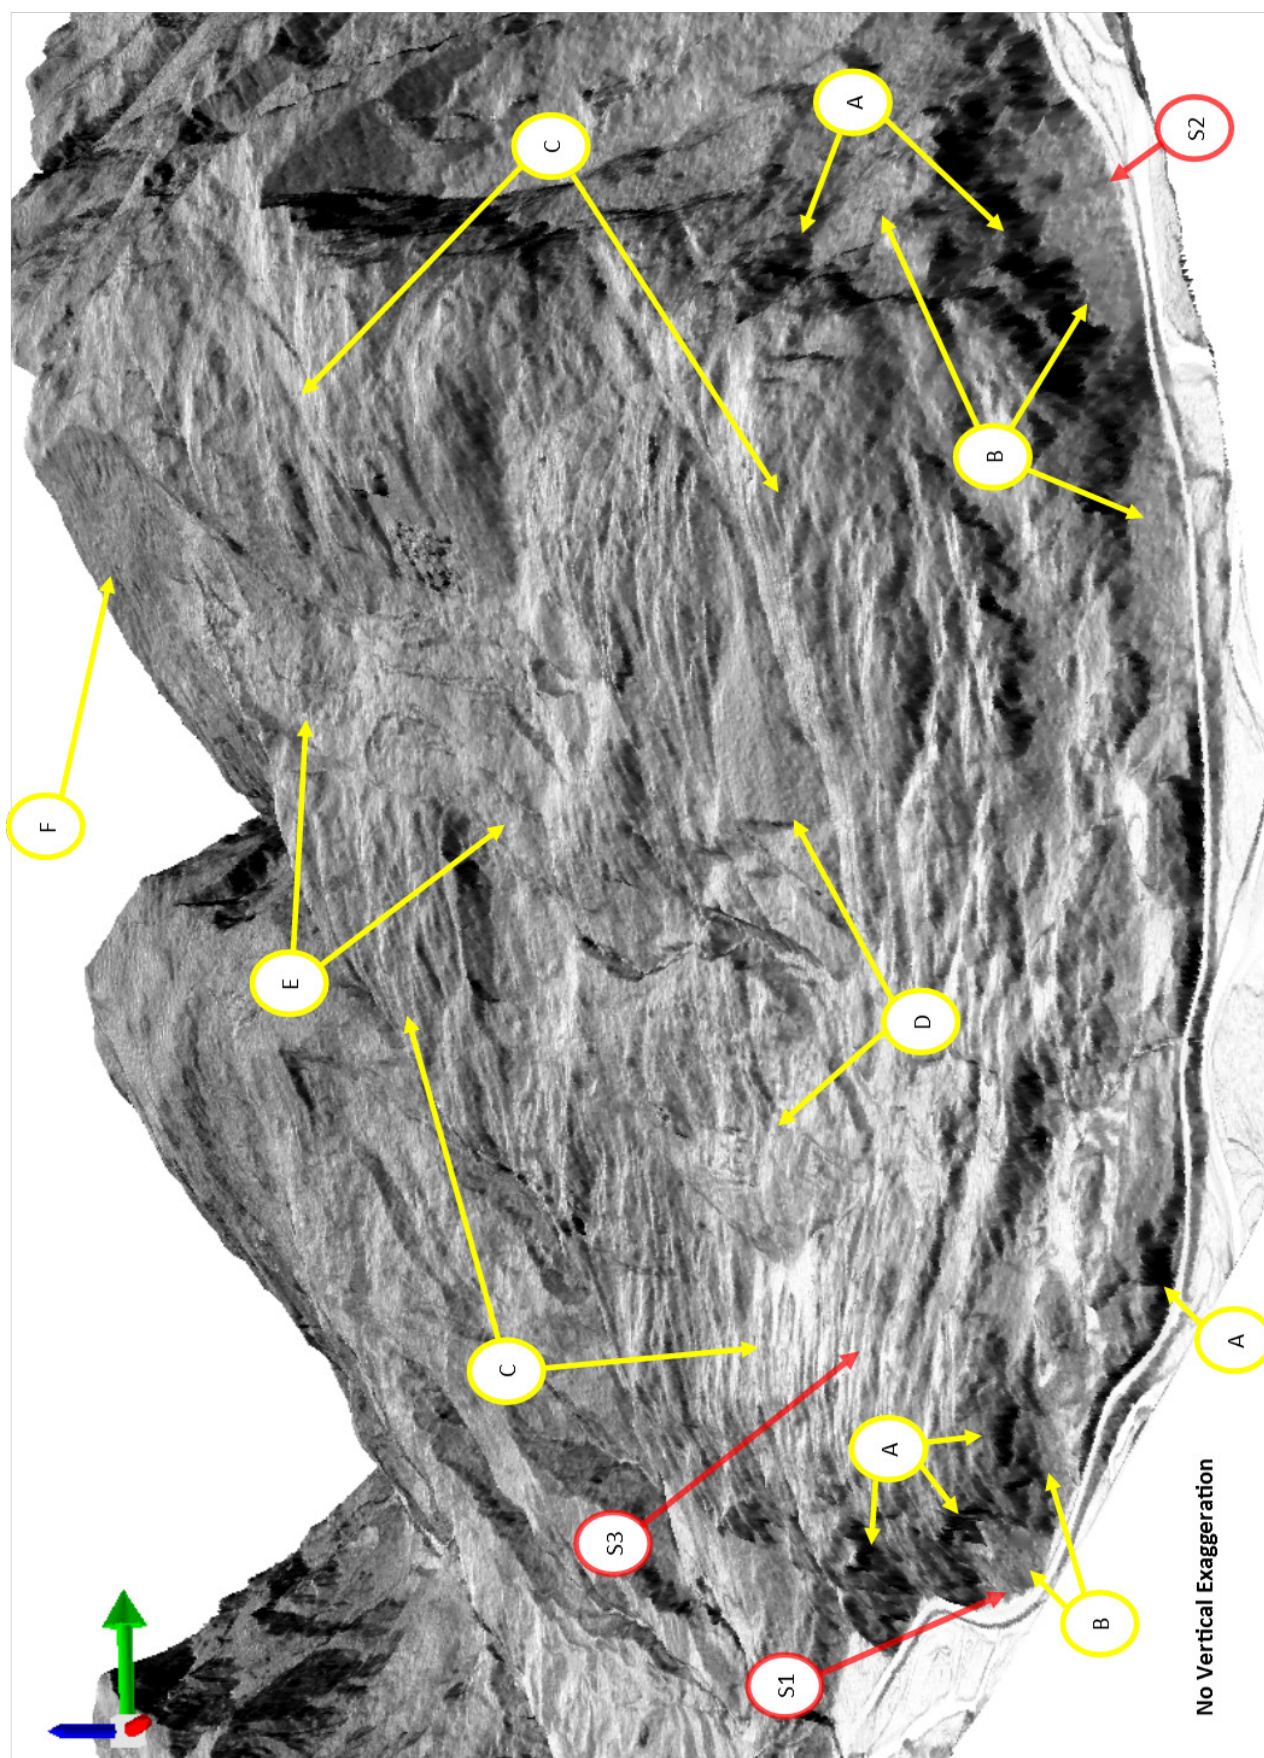
The areas adjacent to the highway are composed of a combination of steep bedrock cliffs and regolith deposits. The bedrock cliffs appear as the dark surfaces next to the highway in the LiDAR model and consist of 30 to 40 metre high vertical faces above the highway and five to ten meter high faces next to the highway where the road has been cut into the rock (Figure 3.15 A). Below these cliffs the surface textures appear rough and undulating with slope angles of between twenty five and forty degrees. This rough and undulating surface represents regolith deposits likely sourced from the cliffs above (Figure 3.15 B). The highway in this area either crosses the base of these regolith deposits or is located beneath bedrock cliffs next to the highway.

Above the cliffs next to the highway the slopes are largely composed of bedrock with a large deposit of regolith in the middle of the slope. Bedrock structures are visible across most of the lower slope appearing as sets of ridges aligned with foliation. These parallel ridges extend up the southern and northern sides of the slope and indicate the presence of bedrock at the surface in these areas (Figure 3.15 C). The bedrock textures visible at the bottom and sides of the slope are obscured in the centre of the slope where an irregular and rough surface texture is visible. Part of the irregular and rough surface has been eroded by the creek near the bedrock boundary (Figure 3.15 F); the irregular undulating surface extends up slope confined to an area between higher bedrock areas to the north and south. The irregular and undulating textures represents regolith deposited after a large landslide. The source this landslide appears to be the large planar surface at the top of the slope where half of the material would have gone into Robinson Creek and the remainder has been deposited on this slope (Figure 3.15 A).

Figure 3.15: Slopesshade image of the LiDAR model. Light colours indicate shallowly sloping areas with steep areas appearing as dark colours. (A) Bedrock cliffs (B) Regolith deposits at the base of bedrock cliffs (C) Schist bedrock textures on lower slopes and either side of regolith covered area on upper slopes (D) Deposits of regolith over bedrock at the base of the upper slope (E) Narrow regolith deposit between two areas of bedrock with internal scarps visible (F) The upper area of the slope consists of a smooth planar surface and is likely the scarp formed by a landslide from this slope.

The final area that was investigated on the ground is situated on the top of one of the parallel ridges identified in the LiDAR Surface analysis (Figure 3.15 S3). The area was interpreted to be composed of schist bedrock, based on the LiDAR model morphology, but the material was unable to be identified from aerial imagery. Site S3, shown in Figure 3.18, is situated in one of the less vegetated areas identified in the aerial photography as a light brown area. The light brown colour observed in the aerial imagery is a result of the moss cover over the bedrock that is visible in the photograph of the site (Figure 3.16 A). The dark area in Figure 3.18A just above the backpack is an exposure of schist rock where moss cover is absent. A close up of the exposure is shown in Figure 3.18B showing a prominent lineation within the rock. This lineation is foliation and measurements of its orientation matched that of schist bedrock in the area. The similarity of the foliation structures observed in this rock with that of schist bedrock indicates that the exposure is composed of schist bedrock and supports the interpretation that the ridges observed in LiDAR represent a schist bedrock surface.

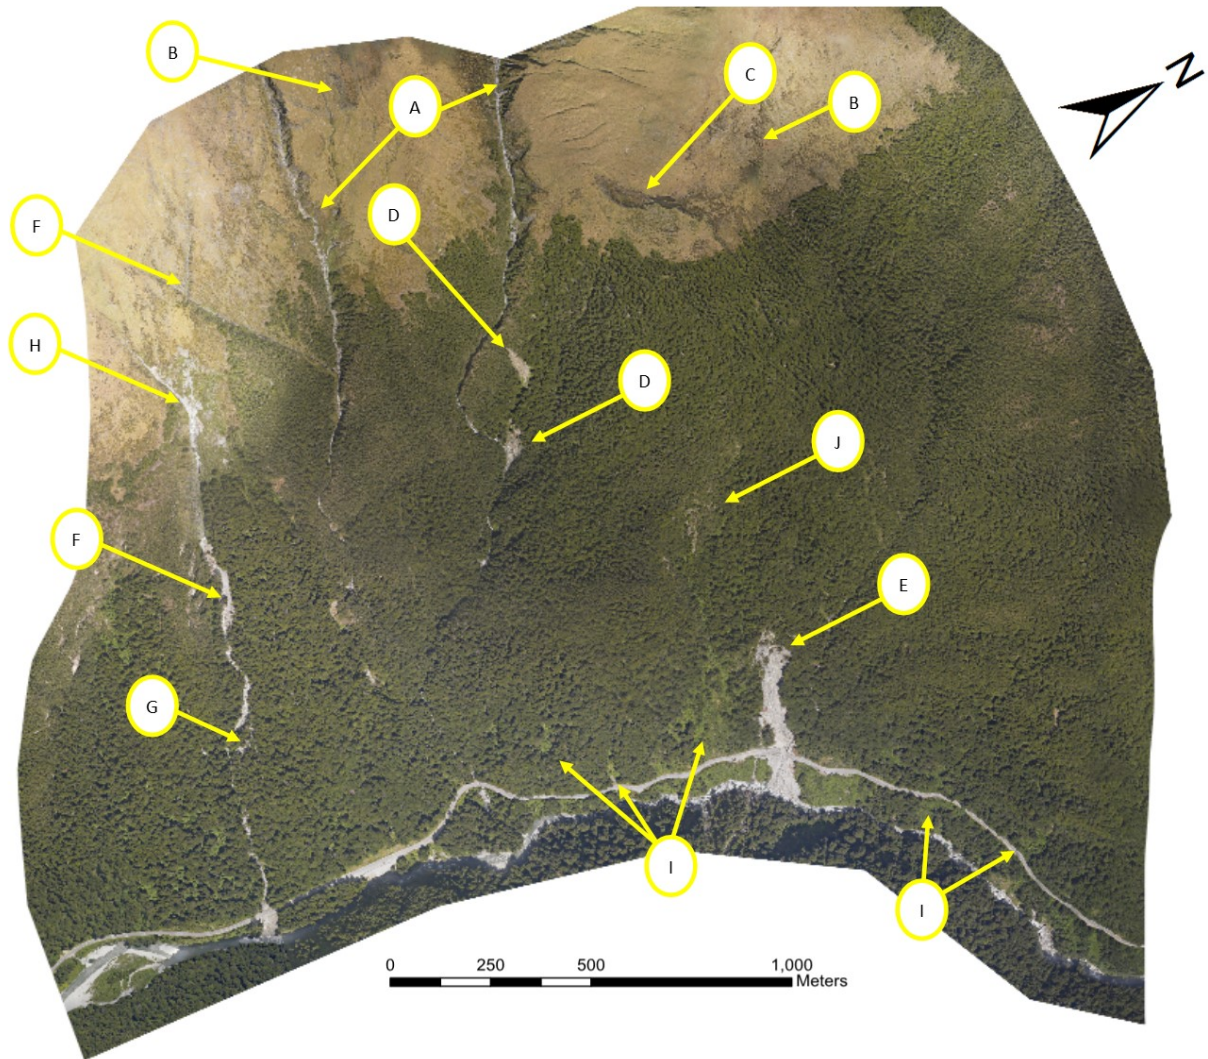
Evidence of recent mass movements are visible in the areas around Pipson Creek. The path of a recent debris flow is visible extending from highway level to the top of the slope where vegetation is absent and a light grey narrow track of remaining material is visible extending down slope (Figure 4.2 F). For most of the length of the debris flow the material has remained confined to the narrow channel of Pipson Creek, however, in one location it appears that material overtopped the channel and flowed alongside the main channel through vegetated areas on the north side of the creek (Figure 4.2 G). The debris flow appears to have originated at the top of the slope where Pipson Creek makes an abrupt bend to the south with the slope above appearing light grey to white in colour (Figure 4.2 H). The light grey colour of the surface compared with the surrounding hillside strongly suggests that a recent landslide has taken place. Since the area is thought to consist of bedrock the mass movement is likely to have been a rock slide or debris slide; it is possible that landslide could have acted as the trigger for the debris flow visible in Pipson Creek, however, without an exact date on when the failure occurred it is not possible to say with certainty.

Figure 4.2: (A)Foliation aligned lineations visible in the sides of creek channels. (B)Bedrock visible as dark areas on light coloured slope with lineations visible. (C)Large cliff of schist rock that may be the headscarp of a larger landslide. (D)Landslide activity has revealed the underlying material that appears to consist of unconsolidated regolith material. (E)Clearly visible regolith material within the Diana Falls landslide area. (F)Light grey material visible running down slope indicates the path of the Pipson Creek Debris flow. (G)Fresh regolith material visible through the vegetation indicates the debris flow moved out of the channel. (H)Area of instability at the top of the slope. (I)Areas where variable aged vegetation indicates previous landslide events. (J)Rockfall visible from a steep section of slope far above the recent Diana Falls landslide.

the zone in Figure 4.2. It is the largest continuous exposures of regolith material on the slope and is clearly visible as the light grey area above to the highway (Figure 4.2 E). The material visible in the aerial photo consists of regolith with some large boulders visible within the regolith material, but most concentrated near the headscarp. To the north and south of Diana Falls a number of small areas of slope are covered by younger vegetation suggesting that recent landslides are not just confined just to Diana Falls but have likely occurred in additional locations alongside the highway(Figure 4.2 I). One of the more intriguing features visible in the area around Diana Falls is the presence of a small rockfall further up slope suggesting that a much larger portion of the slope outside of the 2013 Diana Falls landslide could be unstable (Figure 4.2 J).

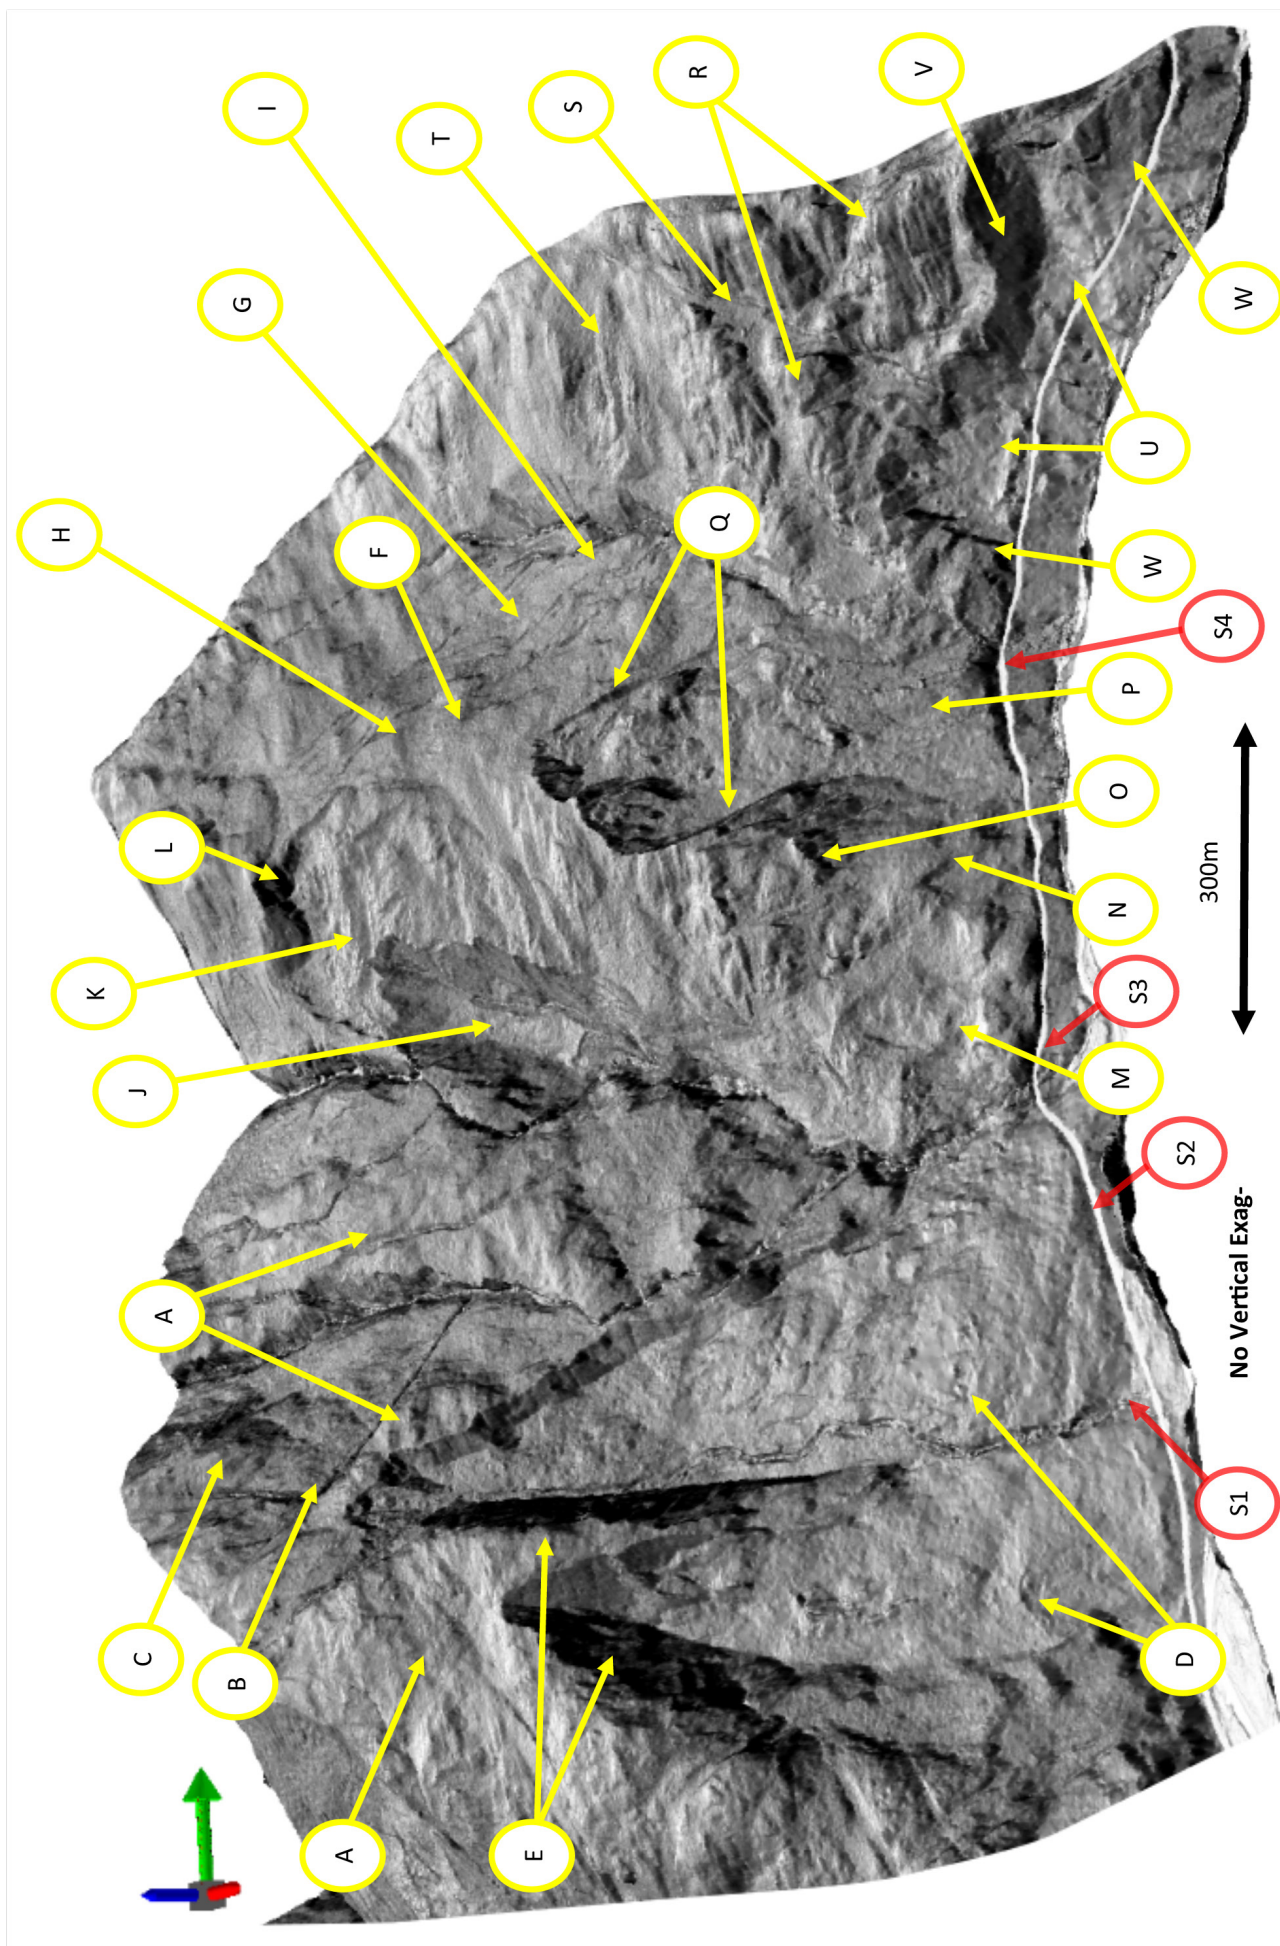
Figure 4.3: Figure caption on next page

Analysis of the upper slope south of Ford Creek indicates the slope is predominantly composed of bedrock with small isolated areas of regolith cover. The LiDAR model of the upper slope changes considerably with some areas consisting of subtle parallel undulations (Figure 4.3 A) and other areas having a rougher irregular texture (Figure 4.3 B). Throughout the upper slope in areas of both parallel undulation and rough textures small vertical cliffs are present and visible as the dark areas in the LiDAR Surface (Figure 4.3 C). Ford Creek and two smaller unnamed creeks cut across the slope flowing in narrow steep sided channels with cliffs visible as the very dark areas in the LiDAR model. The parallel well defined undulations are indicative of bedrock structure influencing surface morphology where it is exposed at the surface, but areas where it is well defined are limited to small areas. On other sections of the slope where bedrock structure becomes more subtle it is clearly still present and visible in the very steep slopes and in the cliffs on the margins of the creek channels. In areas where the rough irregular texture is visible the slope is covered by regolith, however, the cover of regolith on this part of the slope is relatively thin due to subtle bedrock structures influencing the slope's morphology.

Figure 4.3 Caption: LiDAR interpretation of the slopes between Pipson Creek and The Hinge.

- R) Bedrock morphology on the slopes above The Hinge with rockmass defects clearly visible as lineation's running across the slope.
- S) Small deposit of regolith material below the steep slopes consisting of bedrock.

The lower half of the slope between Ford Creek and Diana Falls predominantly comprises regolith with some isolated patches of bedrock. A rough irregular surface is visible on the lower slope just to the north of Ford Creek (Figure 4.3 M), representative of a relatively thick deposit of regolith over bedrock. To the north of the regolith deposit the slope displays a rougher irregular surface morphology near the road (Figure 4.3 N) with a both steep cliffs and parallel undulations higher up (Figure 4.3 O). The irregular rough surface represents a cover of regolith, while the cliffs and parallel undulation above represent an area dominated by bare bedrock with thin patches of regolith scattered around. North of the bedrock dominated part of the slope (Figure 4.3 O), a very rough and irregular surface (Figure 4.3 P) is surrounded by steep abrupt breaks in slope on the southern and upslope sides, and a smaller break in slope on the northern side (Figure 4.3 Q). The very rough irregular surface is caused by the presence of a large deposit of regolith; given its roughness in the LiDAR model it is probably of a greater thickness compared to the regolith adjacent. The pronounced breaks in slope are probably scarps suggesting that the area has been subjected to a very large slope failure in the past with the regolith material representing the remains of the landslide.
